**Cascade Rescue Model 200 Advance Series Rescue Litter  
Destructive Testing Results  
June 27, 2000**

# Cascade Rescue Product Testing

Conducted at Rigging for Rescue in Invermere, BC Canada

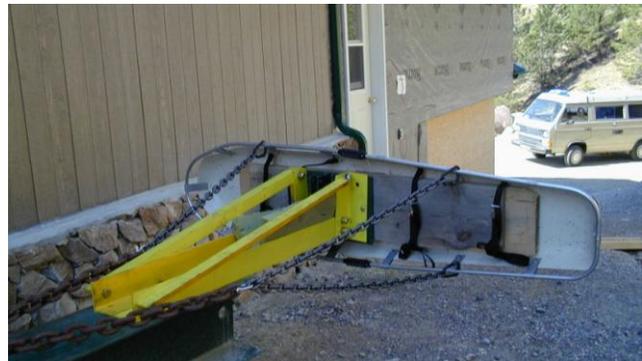
In this test the CTM200 was placed in a Slow Pull Device (SPD) whereby the ram of the SPD applied force directly to the bed of the litter at the point representing the litter's center of gravity under a specially made static harness constructed of heavy gauge chain and attached to the litter with steel carabiners. The distance from the top of the litter harness to the litter in the front was 74.5 inches; 77.5 inches in the rear.

A rigid backboard was manufactured to place in the bottom of the litter to distribute the load of the SPD across the length of the litter. The footprint of the backboard was 60 inches by 11.25 inches. The distance from the center of the ram to the end of the litter was 47.25 inches and from the head of the litter to the ram was 34.75 inches.

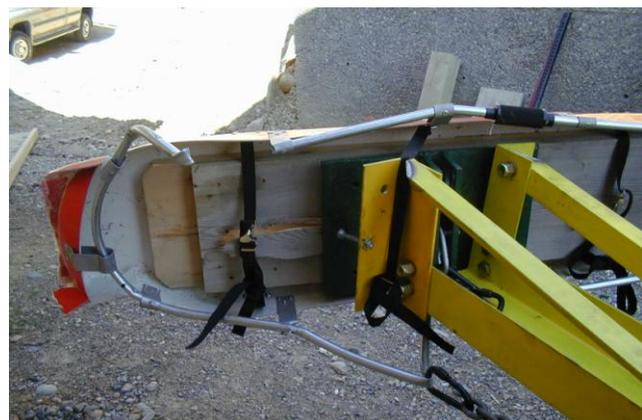
Force was applied gradually over a period of 32 seconds. Approximately 15 seconds into the test the litter sustained a downward load of 39.84kN. At this point the carabiner attached to right forward railing sheared through the railing. Force then dropped to approximately 22kN before climbing back to approximately 30kN when the left front railing sheared through

the bracket closest to the carabiner. At this point, the litter, while badly damaged was still attached to the litter harness by three of four attachment points. After several more seconds it was determined the litter had sustained enough damage to render it inoperable. Absolutely no damage was done to the <sup>1</sup>Fastlock™ System and the remnants of the litter were disassembled at the completion of the test.

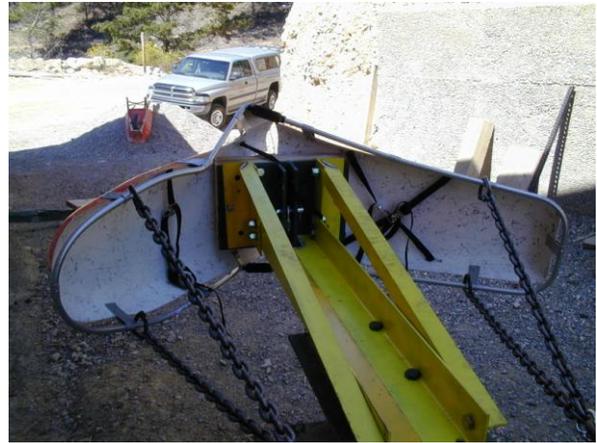
Test Two is identical in all respects to Test One with the exception that the footprint of where a load was applied was reduced to an 18 inch by 11.25 inch area directly over the center of gravity of the litter as it was attached to the static litter harness.

Force was applied gradually over a period of 40 seconds. Approximately 11 seconds into the test the litters sustained a downward load of 10kN. The litter then flexed and at approximately 28 seconds into the test failed at a sustained force of 10.06kN. The central point of failure occurred where the litter railing connected the <sup>1</sup>FastLock™ Coupler. The litter itself remained in one piece, but was considered to be inoperable.

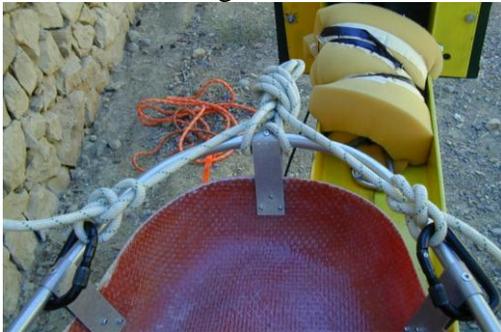
This test was designed to simulate the impact of load placed on the CTM200 if placed in an end to end “Inline” pull. The CTM200 was placed in the SPD and rigged with a 3 point inline litter harness as specified by the Technical Rescue Riggers Guide published by Rick Lipke. The litter harness was constructed of 11mm static Kernmantle rope.

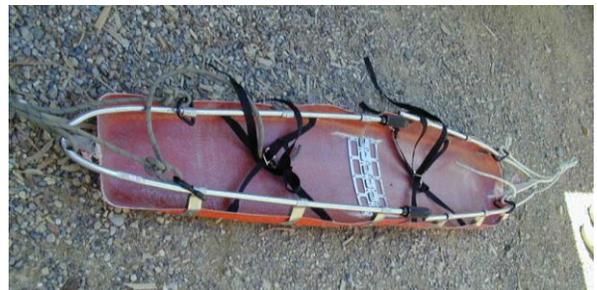
Force was applied gradually over a period of 28 seconds. At approximately 15 seconds force built up to 16.55kN. The first point of failure occurred where the nose railing bracket connected to the shell of the litter. The litter maintained structural integrity at a sustained force in excess of 15 kN until both the left and

right railing brackets at the nose were pulled from the shell and one end of the litter railing sheared from the FastLock™ System. It was observed that the litter was still in one piece and could be considered functional although patient integrity could have been compromised. It was also observed that the railing of the litter was the cause of central failure due to buckling.

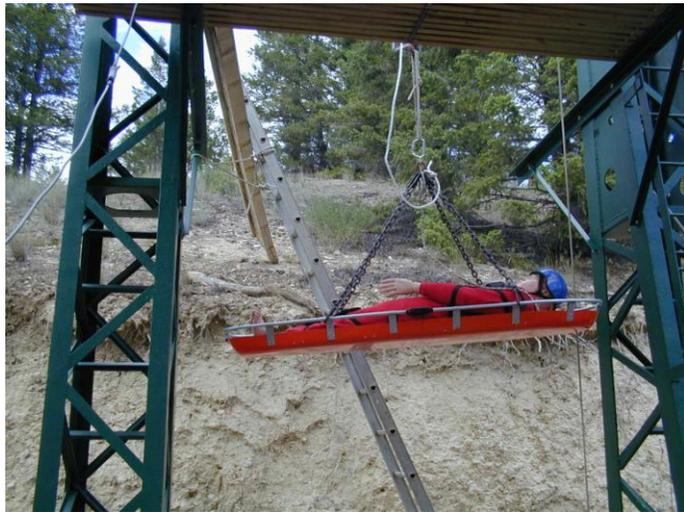
This test simulated a sudden, unexpected drop of the litter and the impact it could sustain from such a drop. The litter was rigged in a static litter bridle constructed of heavy gauge chain and attached to the litter with steel carabiners. The distance from the top of the litter harness to the litter in the front was 41 inches, 38 inches in the rear and 33.5 inches from the axis of the bridle to the railing of the litter at its center of gravity. The litter harness was then attached to three meters of 11mm static rope. The static rope was folded and tied to contain one meter of slack that could be instantly loosed to simulate the drop. The CTM 200 as tested weighed 19 lbs and was loaded with a Rescue Randy weighing 173 pounds for a total weight of 197 pounds. The litter was hoisted up a drop tower for the test.

The CTM200 bounced slightly (approximately 3 inches) upon impact at the bottom of the rope. Impact was measured at 6.52kN. There was a very slight flex at the midpoint of the litter on impact. There was no damage to any part of the litter or railing.

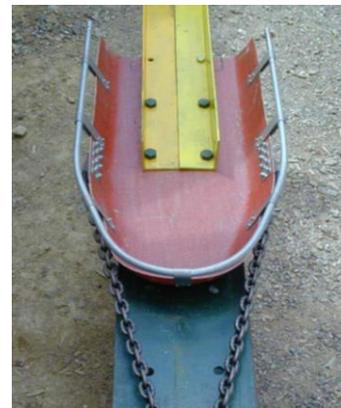
This test was conducted to determine the failure strength of the CTM200 configured with Vertical Pull Brackets used in a vertical raise or lower configuration. The nose end of the litter was used and was bolted to the SPD. A static bridle was attached to the Vertical Pull Brackets and attached to the SPD at a distance of 39.25 inches from the load. The width between the Vertical Pull Brackets was 20 inches.

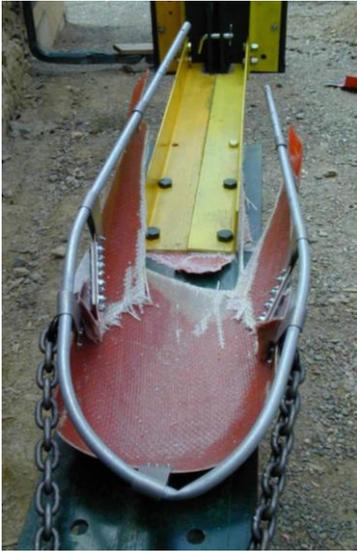
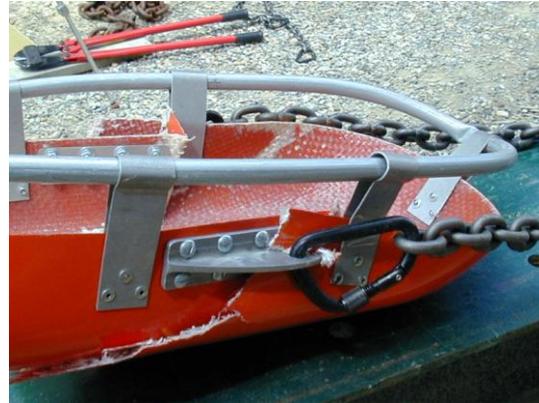
Force was applied over a period of 12 seconds. Peak force applied was 34.58kN at which time large sections of the litter shell cracked and allowed the Vertical Pull Brackets to move forward. As the Vertical Pull Brackets moved forward against the litter railing brackets, force was transferred to the litter railing ultimately causing it to buckle.
